Breguet Marine Chronometer No 3057

by David Walter FBHI.

This fine example of A L Breguet's work c1818 previously belonged to Dr George Daniels CBE and was sold at Sotheby's auction of the Daniels collection on 6 November 2012.

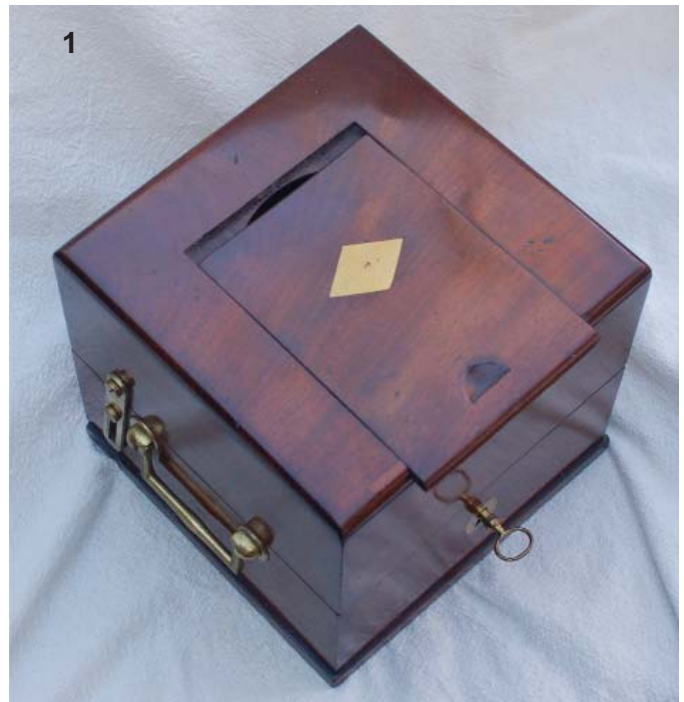
The mahogany case (1) has a sliding inspection cover to view the time displayed. Upon opening the box (2), brass gimbals support the movement and there are two tabs used for locking and transport. The inside of the mahogany cover is recessed to clear the locking tab screws and gimmel supports, while another brass piece set inside the cover very neatly retains the winding key when the cover is closed.

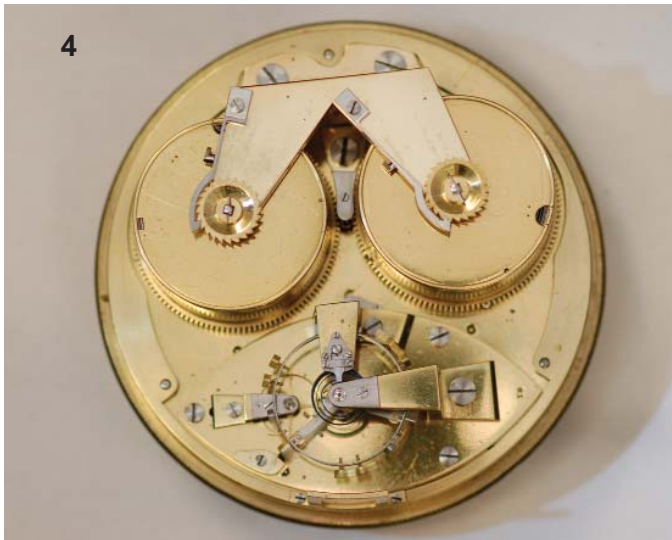
At some time in its life this chronometer has suffered from corrosion, as all the steel work has been resurfaced and left with either a straight grain or circular pattern. Some of the original black polish still exists under the steel endpieces (5) as do remains of bluing under the screw heads. Several of the pinions had old surface corrosion; this was carefully removed. All pivots running in brass, including the barrel pivots, had been re-bushed in the past and were in need of new bushes once again. This is a good indication of the amount of service this instrument has experienced.

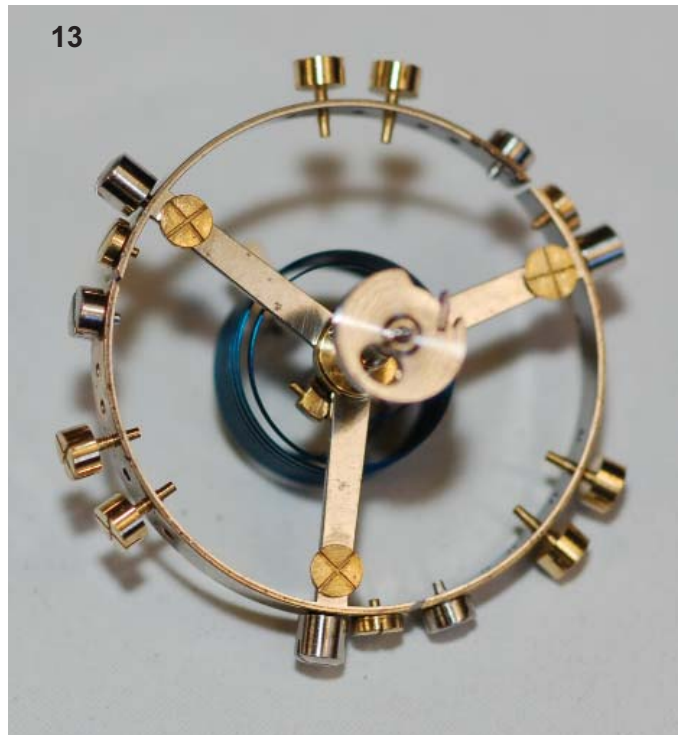
The underside of the balance (13) shows the steel impulse roller with a large cutout in the area of the impulse jewel, the roller has been counter poised opposite the impulse jewel by the opening of an oval hole.

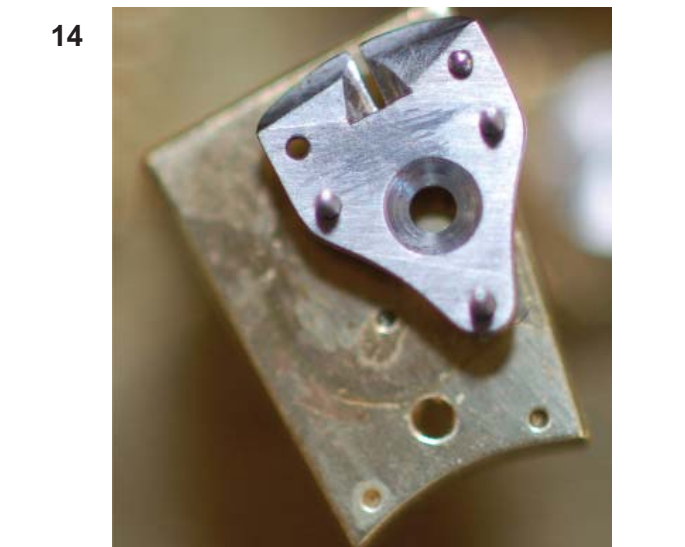
The endpieces are all steel with the endpieces to the balance and escapement having diamond endstones set into the steel. In (15), the two examples on the left are of the underside. Setting stones into steel is quite a difficult task and much more difficult than setting into brass. The unfortunate use of abrasives on the steel is very clear in this photo.
